Geology BAER Report
Terwilliger Fire, Willamette National Forest
October 2018
Bart Wills

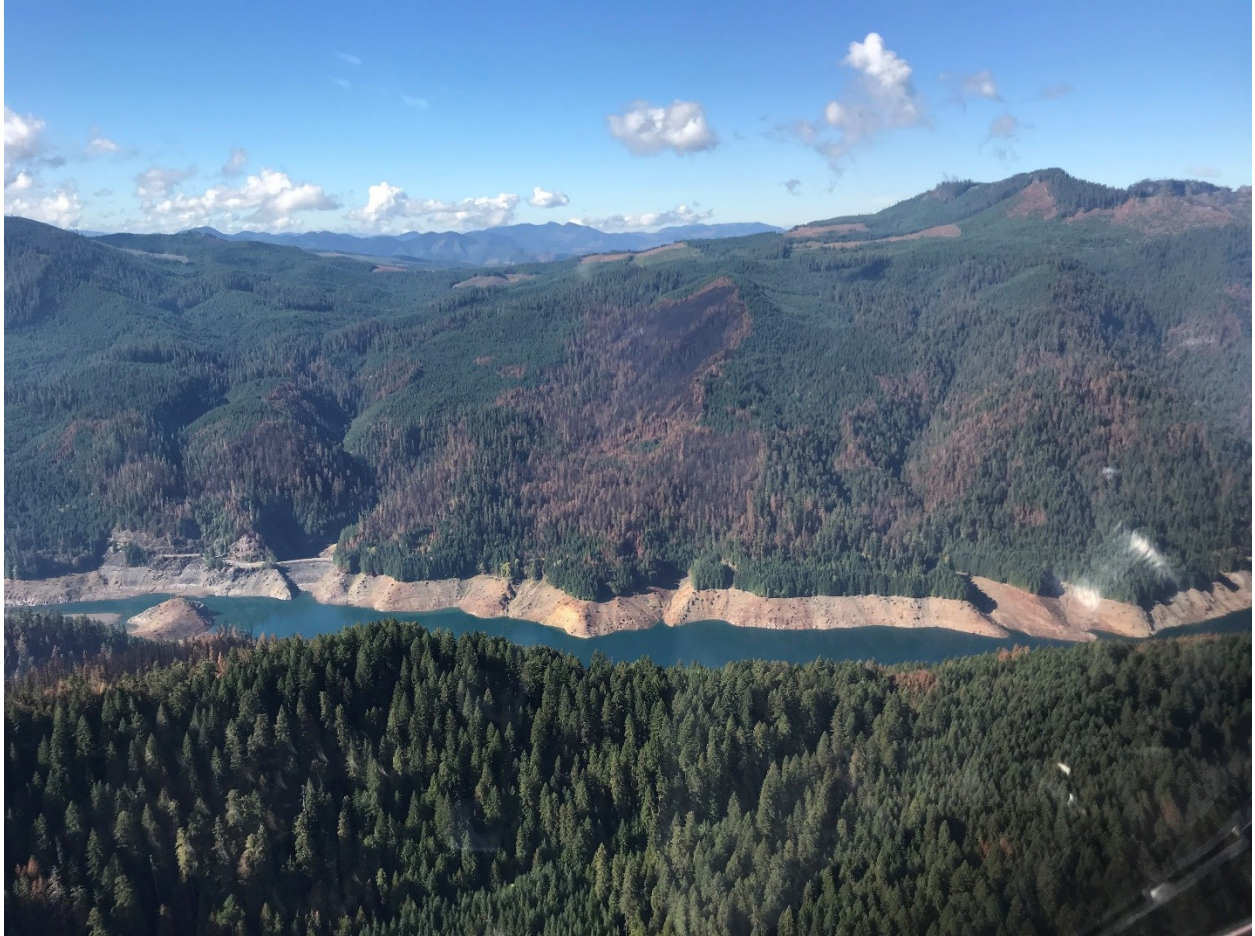
- 1. FSR 1900 at Boone Creek** - Landslide inventory indicates deep seated landslide deposits mid-slope overlying Tuff of Cougar Reservoir (Ttc) which is a mix of highly weathered debris flow deposits, volcanoclastic material, and non-welded ash flow tuff. Historically, the weathered Ttc unit has moved as an earth flow and has been explored by USFS engineering geologists. Drilled piezometers and tilt meters were installed but were not found during field visits. The channels of Boone Creek are sinuous and rough with large logs and not representative of classic straighter debris with less roughness. The debris flow model the combined hazard of the main channel and hillslopes as moderate probability. Based on field evidence, this estimate may be accurate.

Photo 1: Looking west across Cougar Reservoir at high severity burn in Boon Creek.

Critical Value	Probability of Damage or Loss	Magnitude of Consequence	Risk	Treatment
Property	Likely	Moderate	High	Storm Inspection and Response (RT2)

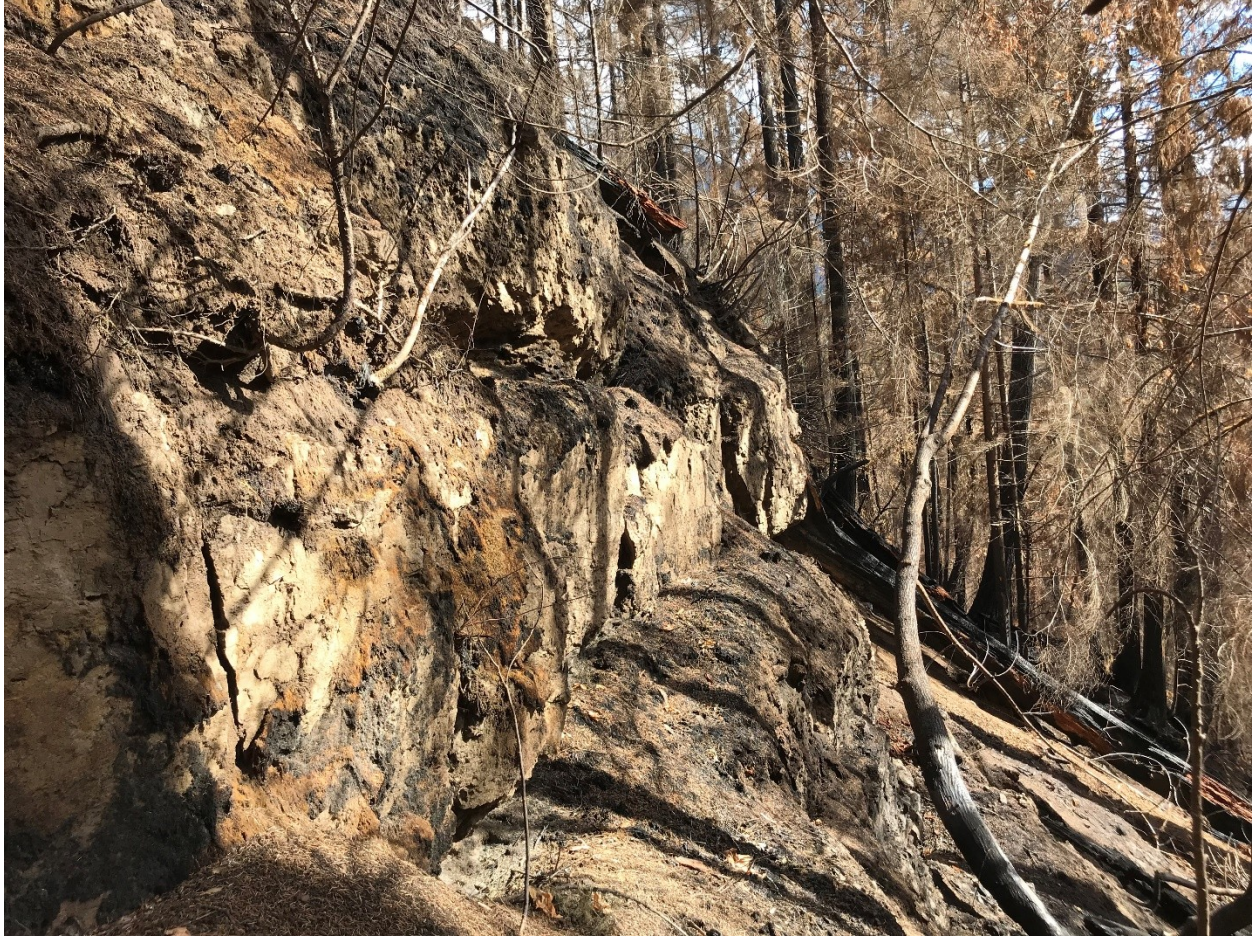
Photo 2: Lower Boone Creek, recent landslide scarp on north side of channel, approximately 400 feet from FSR 1900

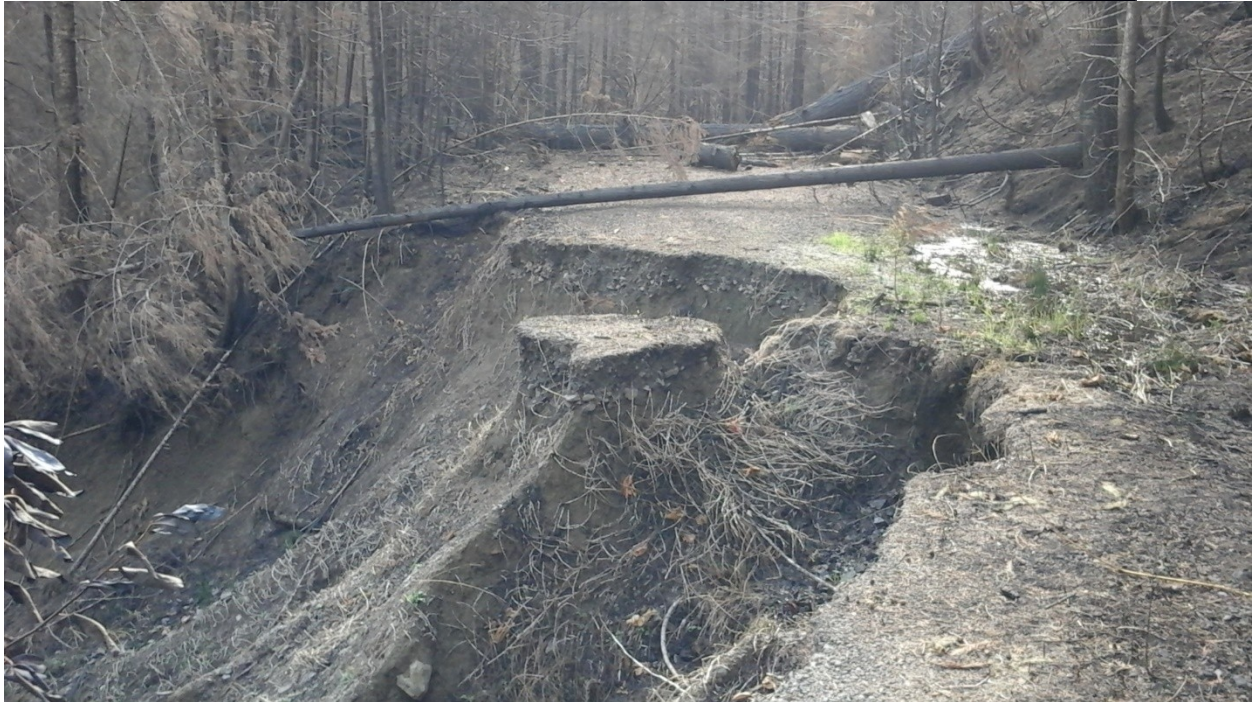
2. **FSR 1985-115 at Boone Creek** - FSR 115 leads into the interior of a high burn severity portion of the fire and the upper portions of the inventoried deep seated landslide. Observations along FSR 115 revealed a small pre-fire landslide scarp approximately 60 feet wide and removed about two-thirds of the road prism from a small tributary along FSR 115 just north of Boone Creek main channel. The debris flow model Combined Hazard for the upper portion of channel is moderate to high and the Combined Hazard for the upper portion of hillslope is moderate. The tributary crossing the road landslide scarp has a Combined Hazard of high. Based on field evidence, sinuosity of the channel and high channel roughness, this estimate may be high.

Photo 3: FSR 1985-115 pre-existing prism failure; looking south, boundary between moderate and high severity burn area

Life	Possible	Major	High	Post-fire hazards present - recommend administrative closure (with existing gate)
------	----------	-------	------	--

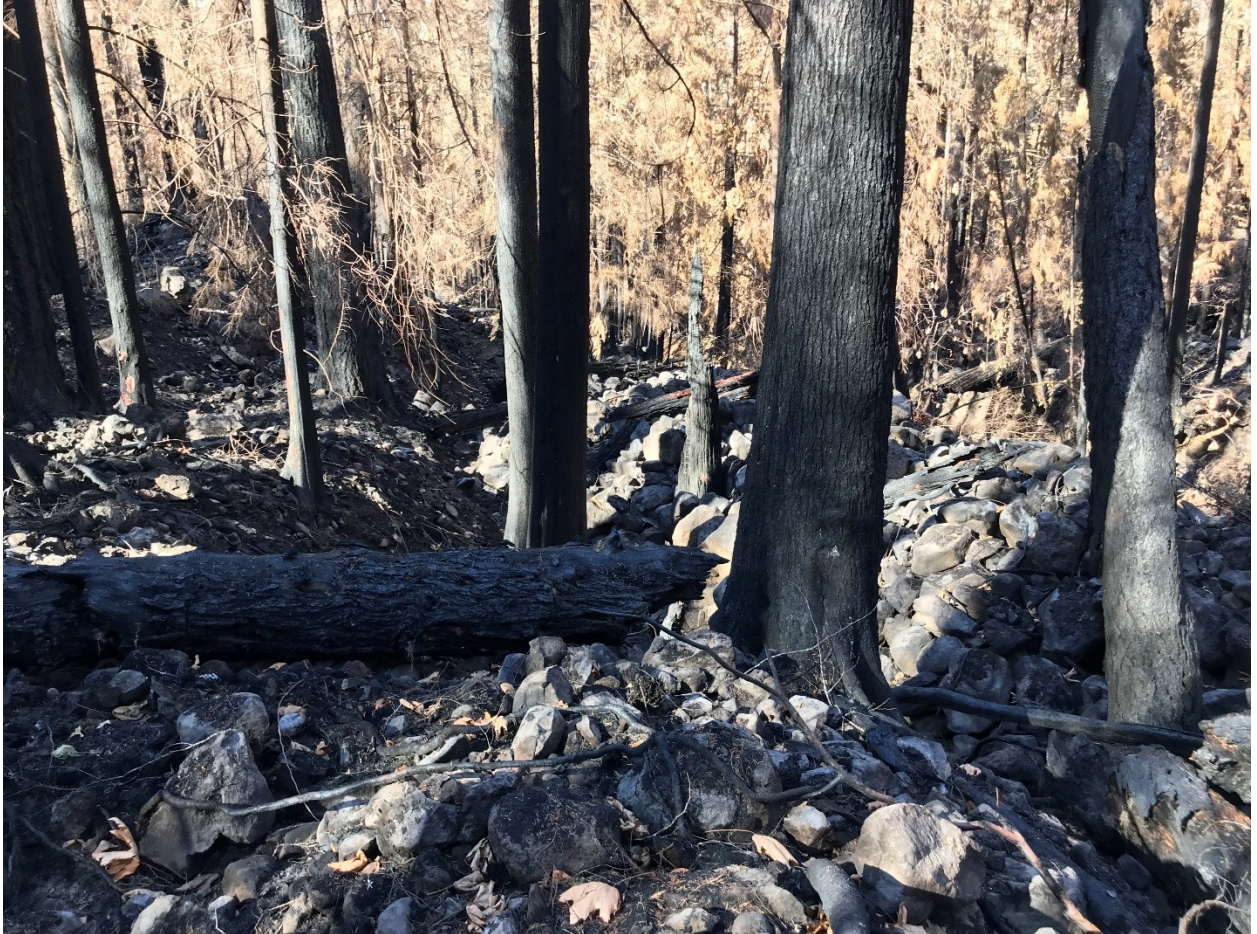
3. FSR 1900-500 at Slide Creek - East side of Cougar Reservoir is very different from the deep seated landslide terrain on the west side. There are no inventoried landslide deposits east of the reservoir. The slopes are generally steeper and the channels run straighter, more like classic debris flow channels, that continue past Slide Creek Campground and into the reservoir (before it was filled). The field observations of Tipso Butte above Slide Creek is composed of steep, basaltic cliffs and talas chutes with no vegetation. Field observations into the lower slopes revealed a channel morphology that is deep, braided, and composed of numerous relic debris flow deposits. Channel roughness has extremely large, rounded boulders and old growth forest and large wood debris. The upper slopes were low to moderate burn severity and the lower slopes were mostly moderate to some high burn severity. Though moderate to high burn severity the slopes are still stacked with slightly burned down wood in lower slopes and channel adding to channel roughness. The debris flow model Combined Hazard for the channel is low to moderate and the Combined Hazard for hillslope is moderate. **Conclusion:** Based on field evidence, sinuosity of the channel, and high channel roughness; the debris model estimate may be high. To activate this debris material in this channel would take much more than the

designed storm to activate. If debris would start, it likely would not reach campground or reservoir.

Photo 4: Slide Creek channel, moderate burn severity

Critical Value	Probability of Damage or Loss	Magnitude of Consequence	Risk	Treatment
Property	Likely	Moderate	High	Storm Inspection and Response (RT2)

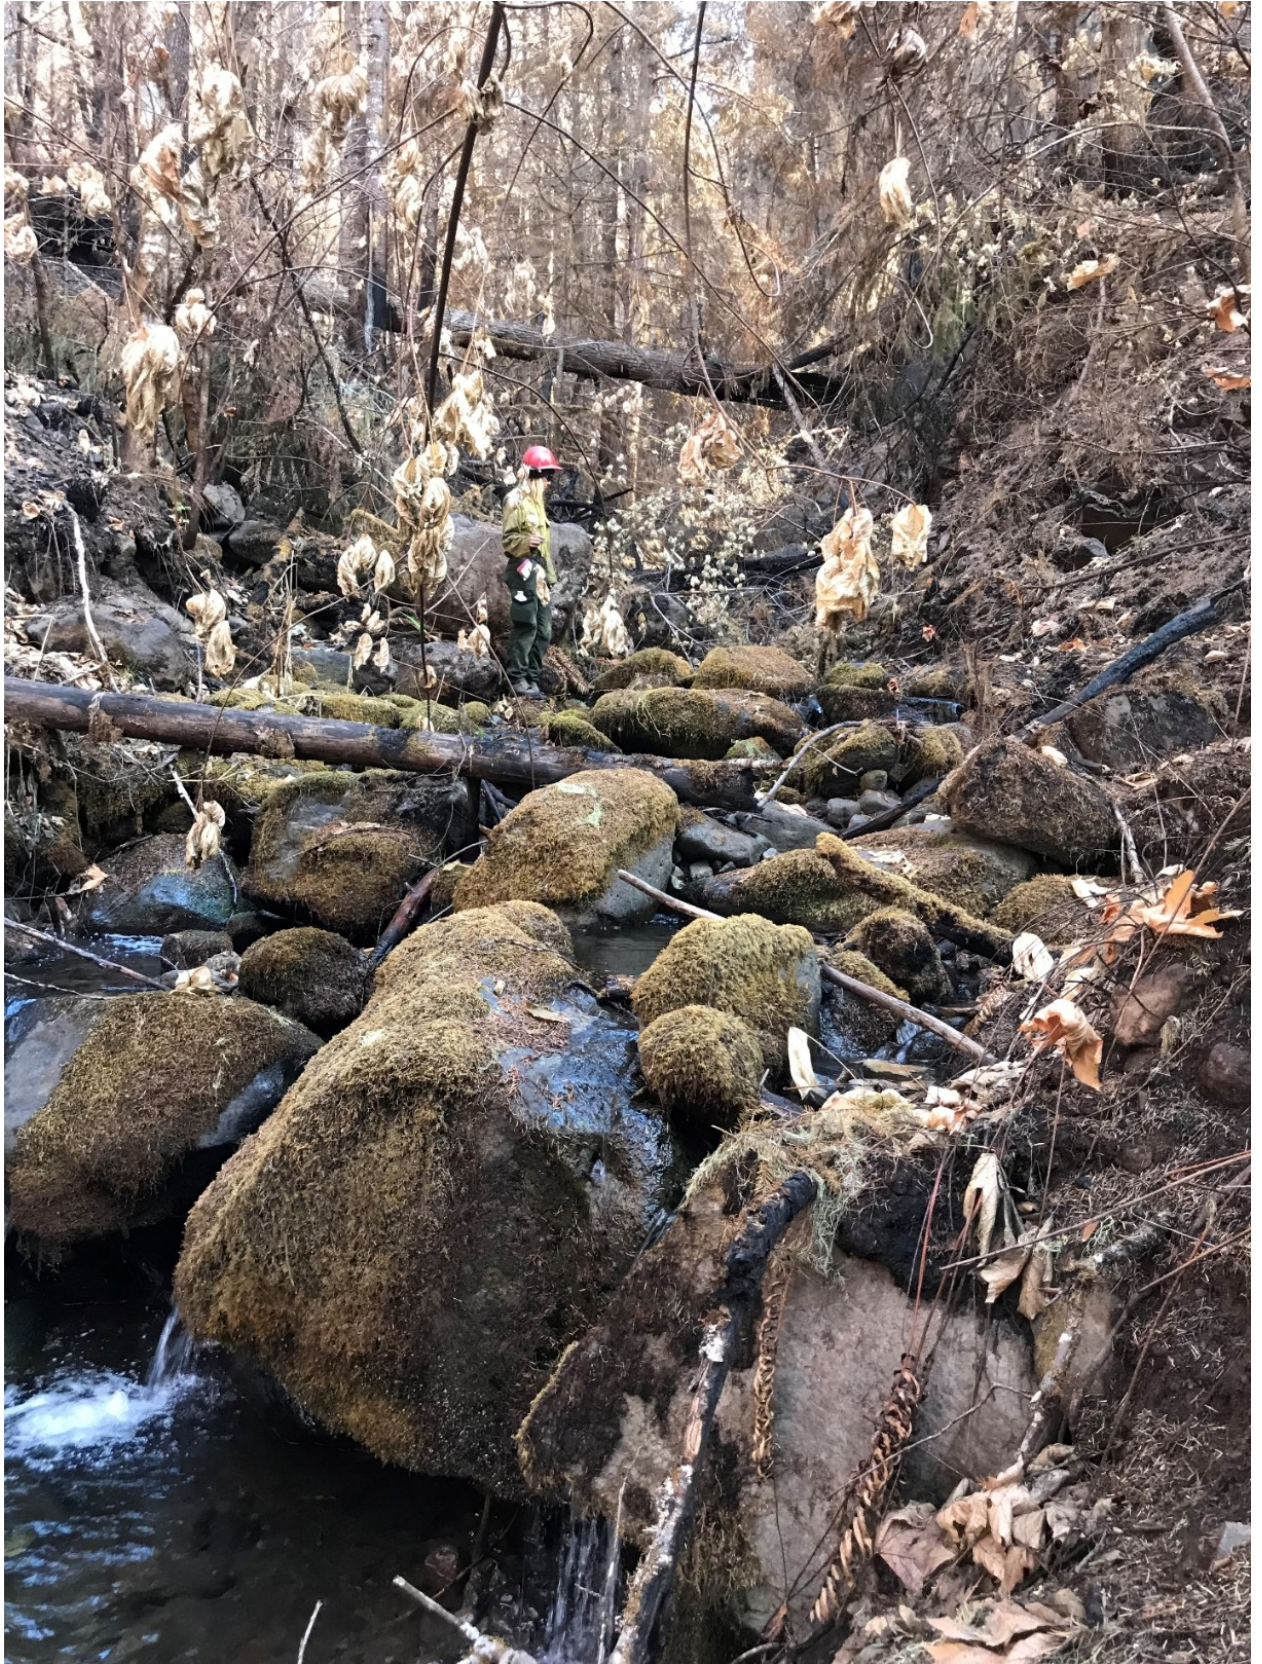
- 4. FSR 1900-500 at Smith Creek** - Very similar channel as Slide Creek and shares the same steep cliffs and talas chutes. The channel is a slightly more sinuous than Slide Creek and does not have the massive relic debris flow channels of Smith are not present. However, Smith Creek has a more defined alluvial fan which Sunnyside Campground is located. The debris flow model Combined Hazard for the main channel is moderate with low potential tributaries. The Combined Hazard for hillslope is moderate. **Conclusion:** Based on field evidence, sinuosity of the channel, and high channel

roughness; the debris model estimate may be high. To activate this debris material in this channel would take much more than the designed storm to activate. If debris would start, it likely would not reach campground or reservoir.

Photo 5: Lower Smith Creek, moderate burn severity, note roughness of channel

Critical Value	Probability of Damage or Loss	Magnitude of Consequence	Risk	Treatment
Property	Likely	Moderate	High	Storm Inspection and Response (RT2)

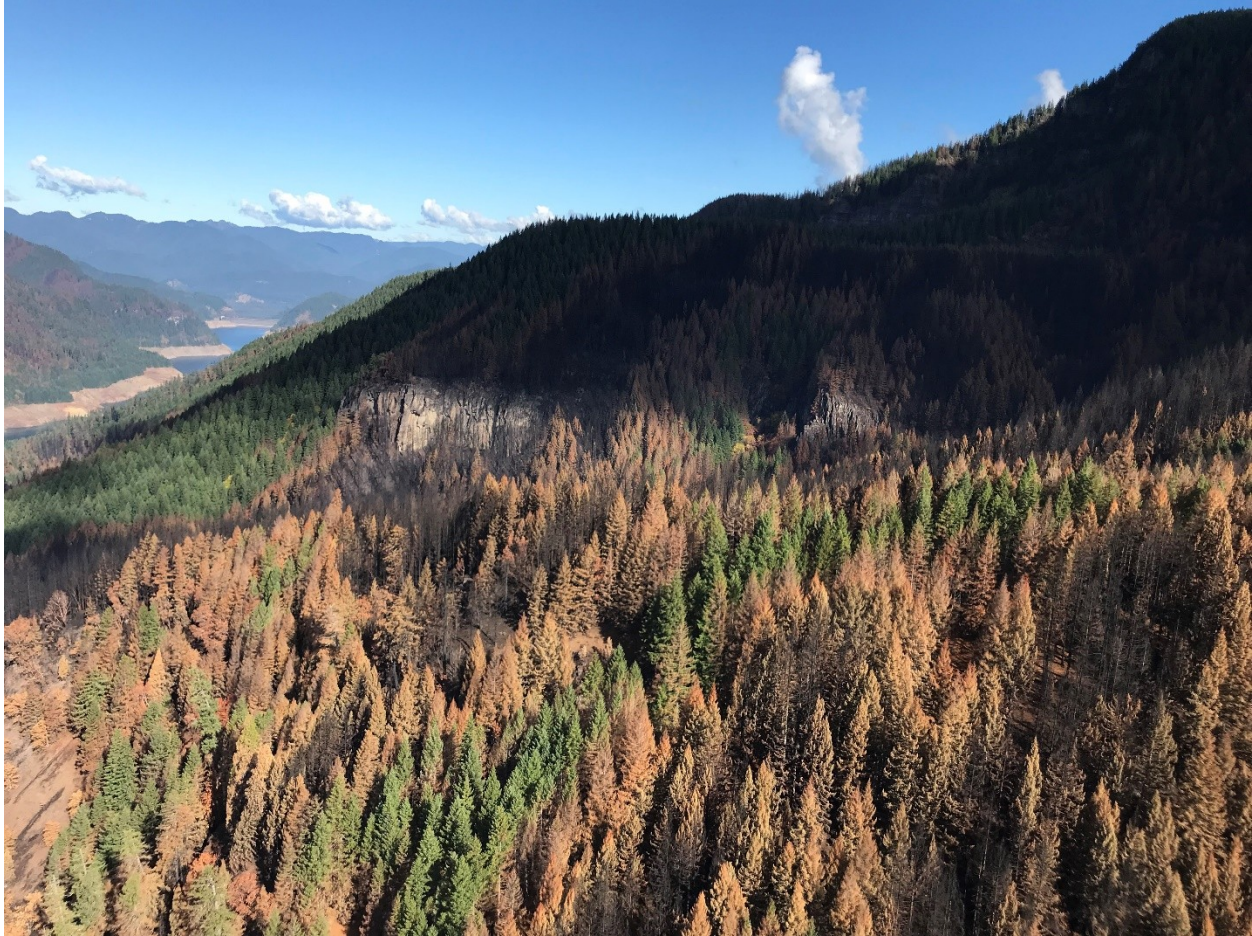
FSR 1900-500 at unnamed creek - This unnamed creek lies approximately halfway between Sunnyside and Cougar Crossing Campgrounds. It has a relatively small drainage area as compared to Slide and Smith Creeks above. This drainage also begins at the steep cliffs of Tipso Butte and has a moderately sinuous channel with small alluvial fan development. The burn severity of the upper slopes was unburned to low, the middle to upper slopes high burn severity and middle to toe slopes low burn severity. Within the high burn severity were steep cliffs low on the ridge. The debris flow model Combined Hazard for the main channel is high and the Combined Hazard for hillslope is high. Of all the potential debris flow basin within the fire's perimeter, this unnamed creek has the high probability according to the debris flow model. **Conclusion:** Based on aerial reconnaissance and sinuosity of the channel, the debris model estimate may be high. Similar to Slide and Smith Creeks, to activate the debris material in this channel would take much more than the designed storm. If debris would start, it likely would not reach the reservoir.

Photo 6: Aerial, looking north at high burn severity on the unnamed creek (located at FSR 1900-500 between Sunnyside and Cougar Crossing Campgrounds)

Critical Value	Probability of Damage or Loss	Magnitude of Consequence	Risk	Treatment
Property	Likely	Moderate	High	Storm Inspection and Response (RT2)

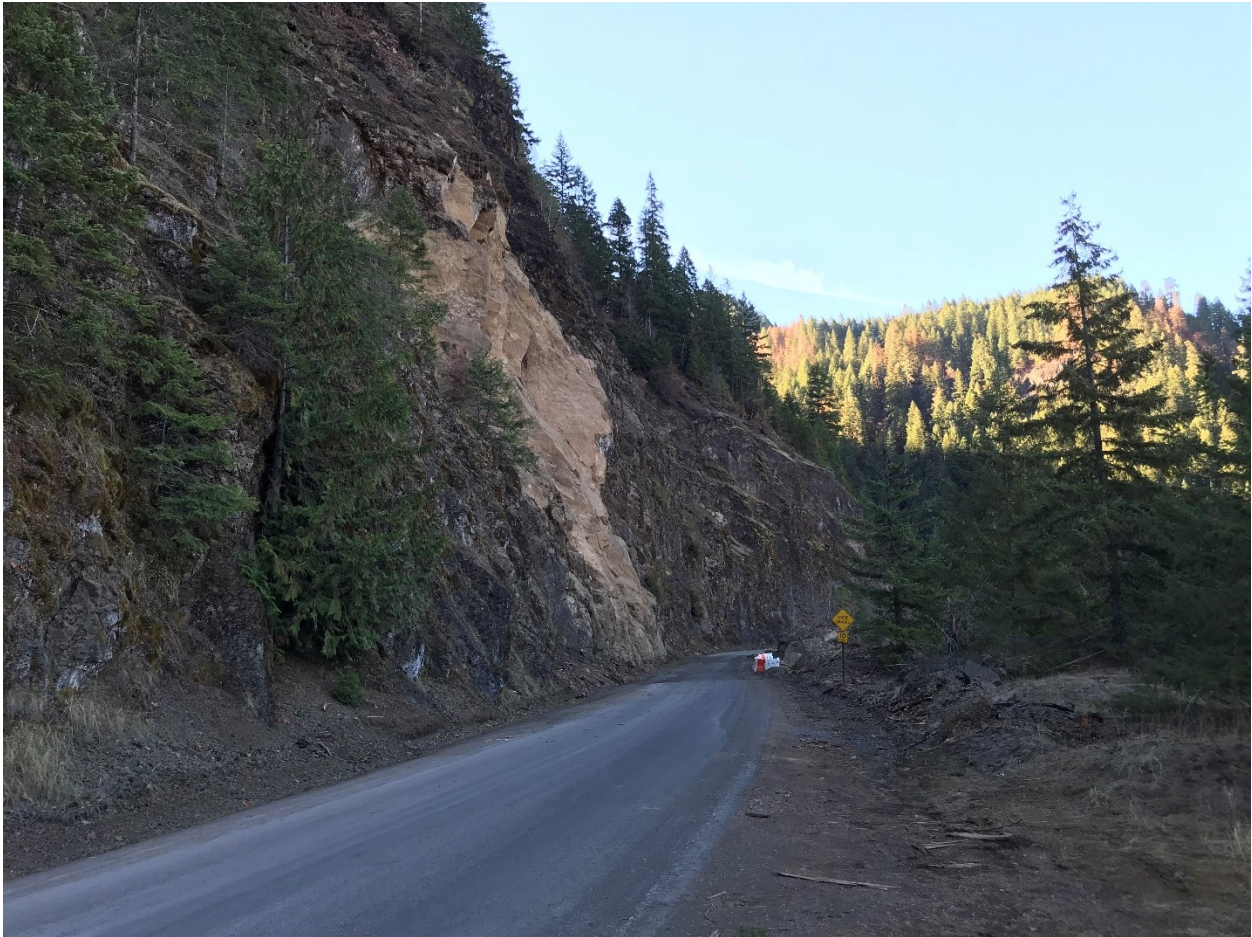
1. **FSR 1900 (Aufderheide Drive National Forest Scenic Byway)** - FSR 1900 is National Forest Scenic Byway, economically important to the areas of McKenzie and Blue River, and major connector road from McKenzie to Oakridge. The road also provides access to the very popular Terwilliger Hot Springs Recreation Site. Rockfall is the natural downward motion of a detached block or series of blocks with a small volume involving free falling, bouncing, rolling, and sliding. FSR 1900 was constructed by cutting and over-steepening rock outcrops to access around the west of the Cougar Reservoir. Over time the fractures in the rocks expand by freeze-thaw processes which slowly loosens the rock face and gravity pulls the rock down. Minor rockfall along the FSR 1900 is common with a rare slope failure and rock slide which closes the road for long periods of time. In December 2017, a rockslide closed the road for six months. Fire burn severity along the road is generally **LOW** but fire effect will allow more moisture into the rock fractures possibly increasing potential for rockfall. Fire Suppression funded a scaling service

contract to mitigate the rockfall hazards along the road but did not eliminate the hazard. **Conclusion:** Rockfall hazards have increased along FSR 1900 and FSR 1900-500 from the fire.

Photo 7: Recent rockslide on FSR 1900; this rockslide closed the road for 6 months:
Dec 2017 – July 2018

Critical Value	Probability of Damage or Loss	Magnitude of Consequence	Risk	Treatment
Life	Possible	Major	High	Road Hazard Signs (P1a)

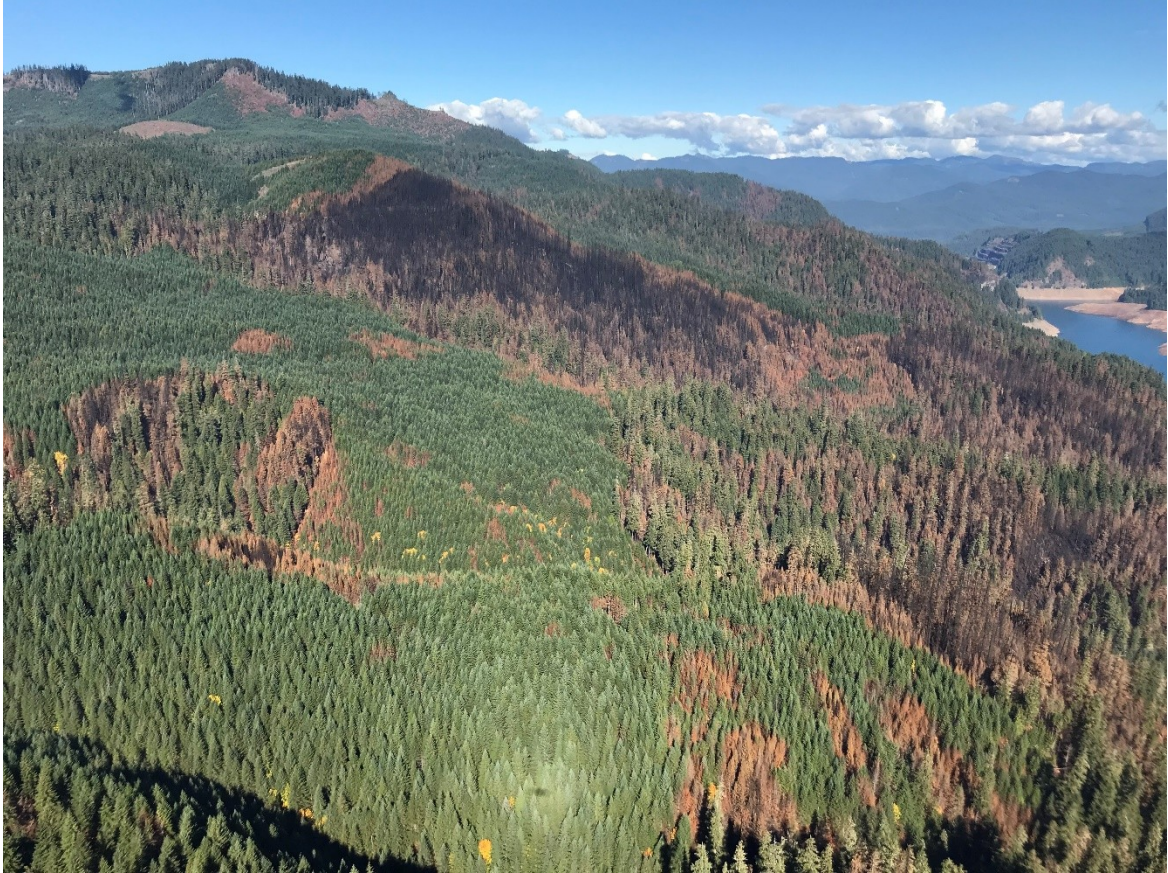
Photo 8: Looking north along west side of reservoir, center high severity burn is Boone Creek, right side is moderate burn severity in area of Terwilliger Hot Springs.

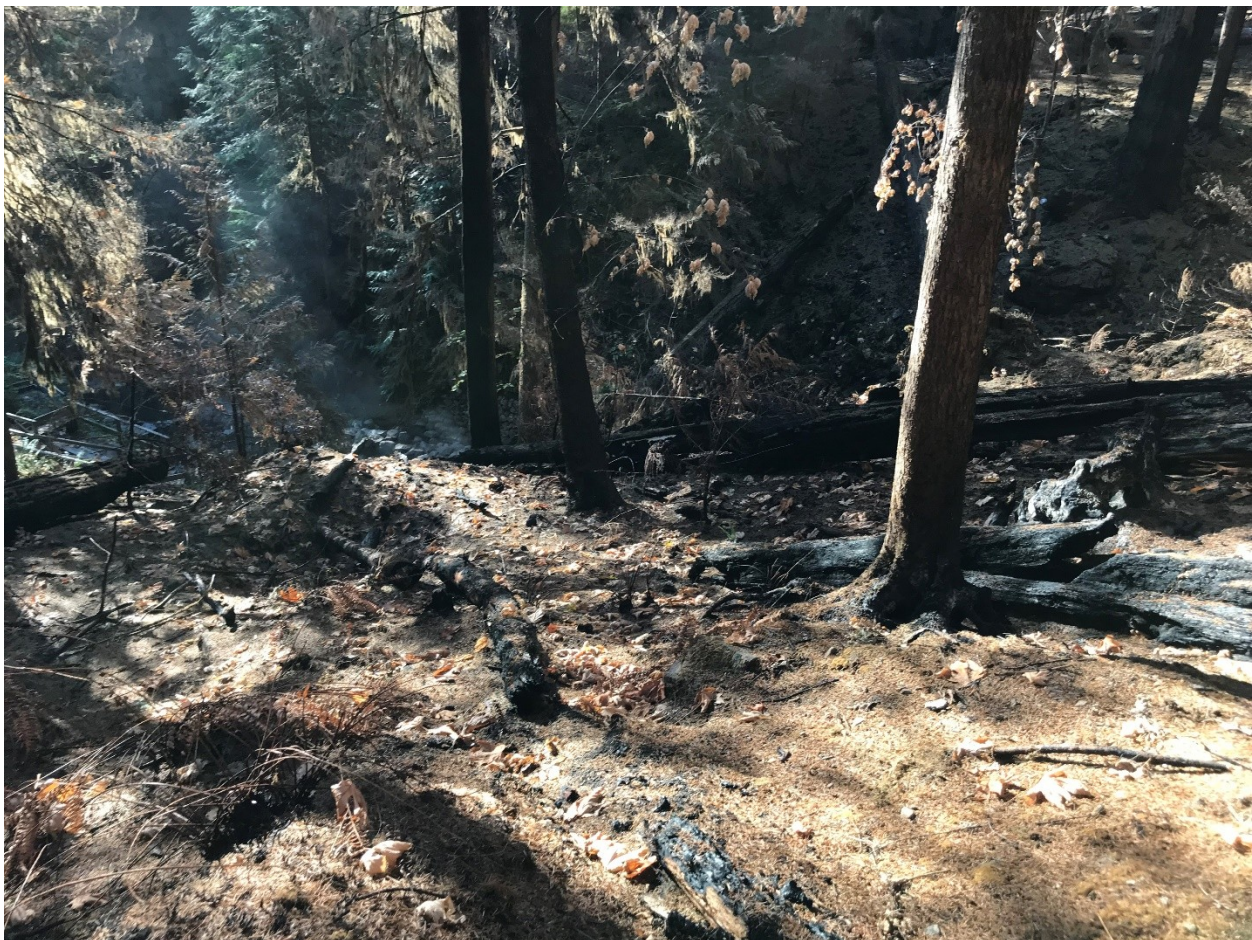
Terwilliger Hot Spring Recreational Site - are very popular geothermal pools that are run by USFS concessionaire contract. The site is very important economically to the community and to the McKenzie River Ranger District recreation program. The water source is above the topmost pool where the spring flows from a rock face at approximately 111 degrees Fahrenheit and cascade down to three lower pools. The upper pools is carved out of the hillside and the pool floors are mostly on bedrock. Over the years people have built up four pools out of river stones and the pools were lastly renovated in 2009. The hillslope above the upper pool has been highly modified and over-steepened with one documented rockfall that almost hit a woman and child. The hot springs flow out of the contact between the inventoried deep seated landslide deposits and the lower Ttc geologic unit (mix of highly weathered debris flow deposits, volcanoclastic material, and non-welded ash flow tuff). The over-steepening of the slope has partially removed the toe of the landslide materials. Burn severity on the slopes above the pools was mapped at Moderate and has removed most of the roughness from the slope. Field observations of the slope revealed over one dozen large cobble sized to small boulder sized rocks exposed with potential to mobilize and fall into the upper pool. No evidence of recent movements and no observed tension cracks on slopes above pools. However, reactivation of deep-seated landslides, possibly related to loss of evapotranspiration and associated elevated groundwater following tree mortality from fire. Possible Loss of soil strength over next 5-10 years from loss of root strength. The debris flow model Combined Hazard for the upper portion of channel is low and the Combined Hazard for the upper portion of hillslope is moderate. Based on field evidence, moderate steep slopes with moderate channel sinuosity and moderate channel roughness, this estimate may be accurate. Based on field observations, a small or moderate debris flow in the channel of unnamed tributary (locally known as "coldwater creek") running parallel to the pools could overflow the channel and undermine the boulders and mortar holding the pools together which would cause all the pools to unravel below.

Photo 9: Looking down slope immediately above Terwilliger Hot Springs, moderate burn severity, steam in center left background from hot springs

Critical Value	Probability of Damage or Loss	Magnitude of Consequence	Risk	Treatment
Life	Possible	Major	High	Site Closure (P10)
Property	Possible	Major	High	Infrastructure Protection (P6)

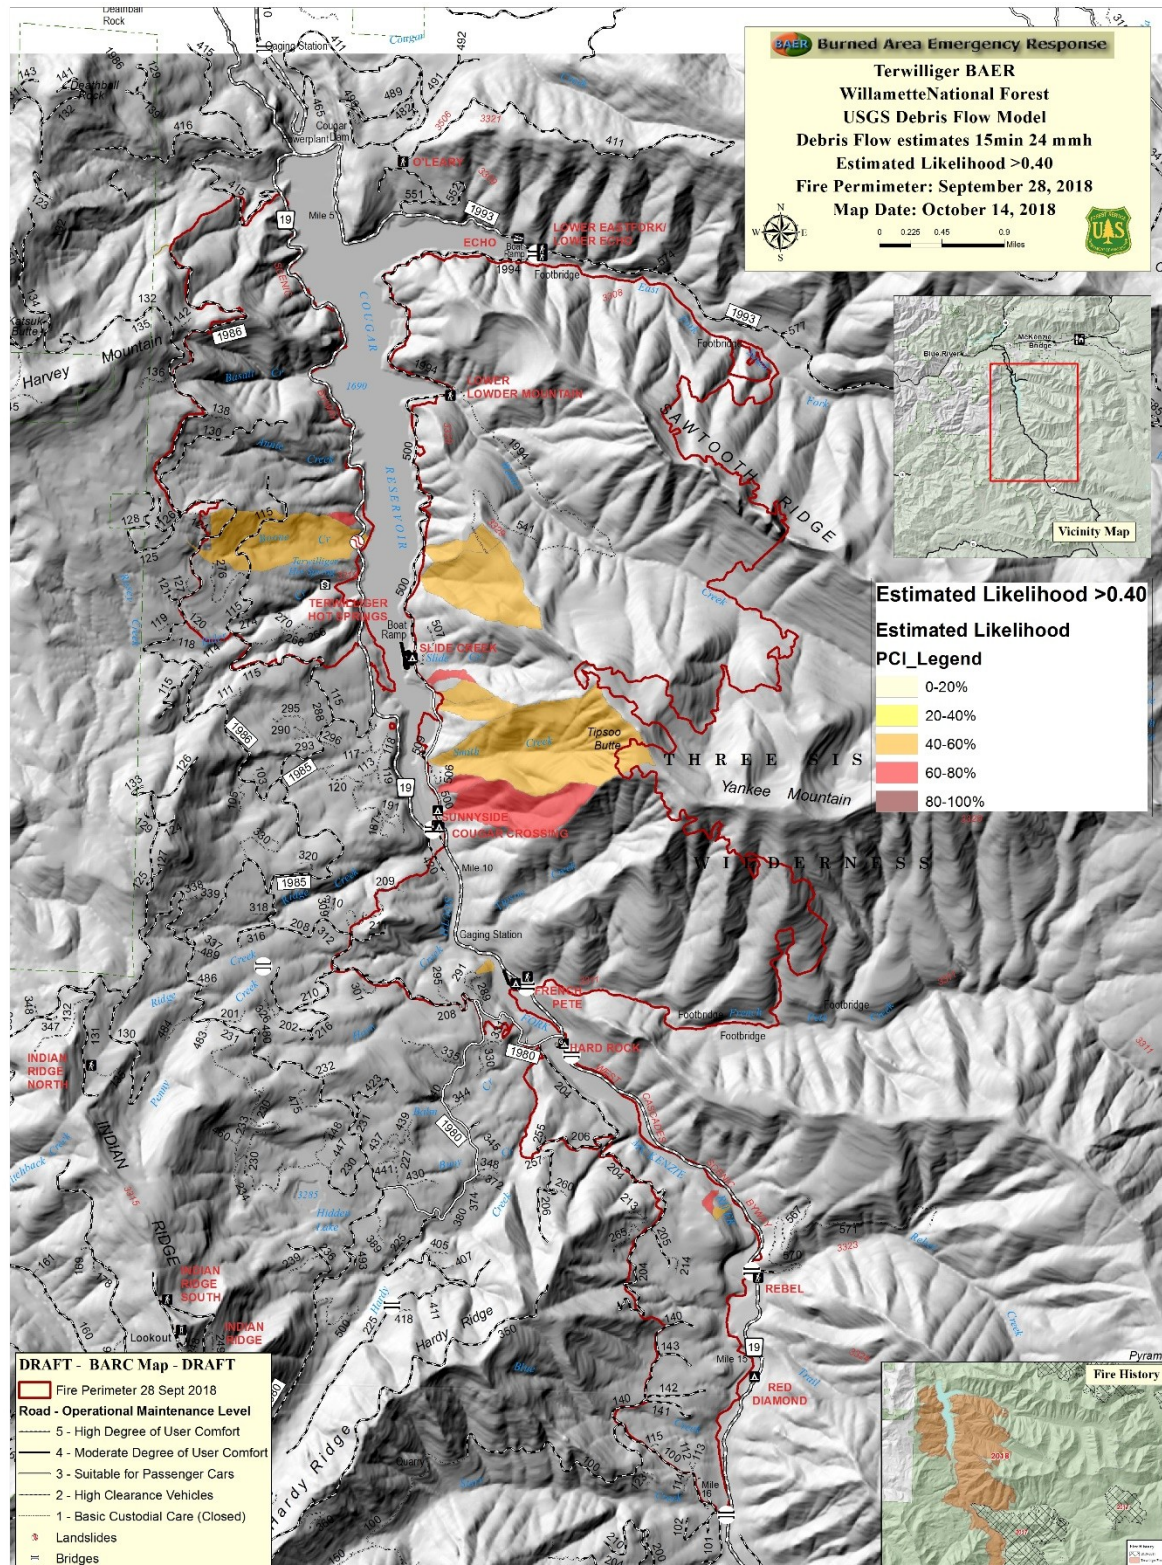
Modelling results generally support field observations that indicate there will be limited post-fire geologic response from a 10-year recurrence interval storm event. Only 7% of drainages have a probability greater than 0.40 for the occurrence of debris flows. Drainages at highest risk for debris flow initiation include Boone Creek, unnamed drainage north of Slide Creek, unnamed drainage between Slide and Smith Creeks, and Smith Creek (see Figure 3 below).

Initial observations in the field and from aerial reconnaissance indicated the drainages highlighted have a lower likelihood of debris flow discharge than the model predict due to sinuosity of stream channels and roughness of channels.

Figure 3: USGS Estimated Likelihood of debris flow based on 15-min/24mmh (short duration/high intensity storm). Only 7% of drainages have a probability greater than 0.40 for the occurrence of debris flows.
